**The BIG '93-95 Mazda RX-7 TSB List**  
**Compiled by Dale Clark**  
**Hosted at <http://www.clubrx.org>**

**Technical Service Bulletins (TSB's)**

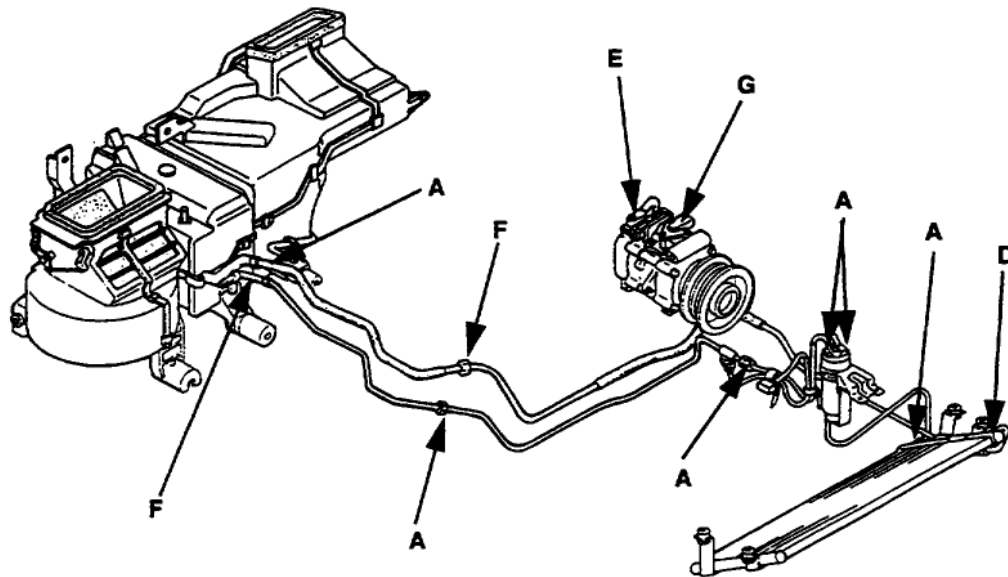
**1995 RX-7**

This has updated part numbers of which O-rings you need for the air conditioning system. There's only a picture of the '95 system in this TSB - there's another TSB with the '93-94 AC O-rings.

Here's a list of O-ring part numbers and quantity. The code corresponds to the O-ring location diagram.

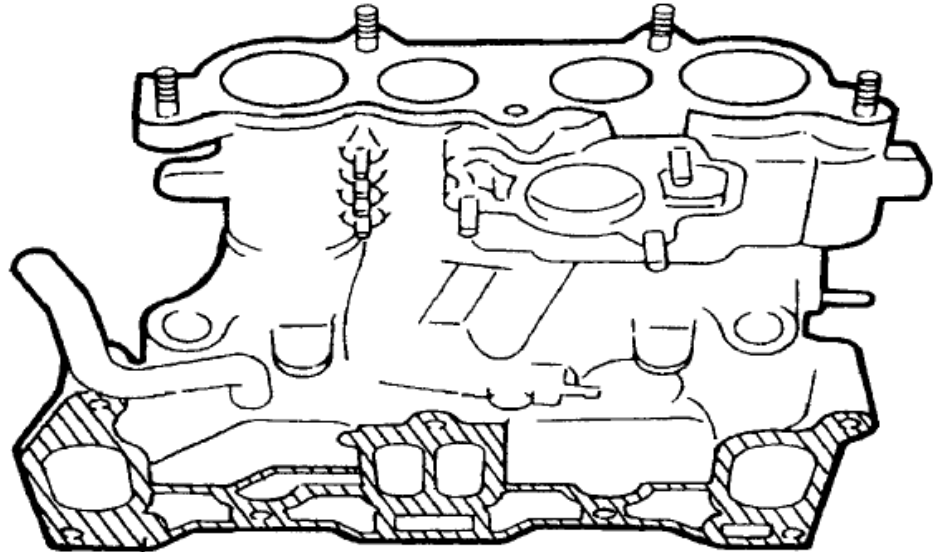
**F00595 JUN 95 Intake Manifold - Rough Idle After Replacing Gasket**

New procedure for tightening the intake manifold. Apply a light film of moly grease to the flange on the lower intake manifold, install it with the gasket, and tighten the bolts in the order shown in the diagram -

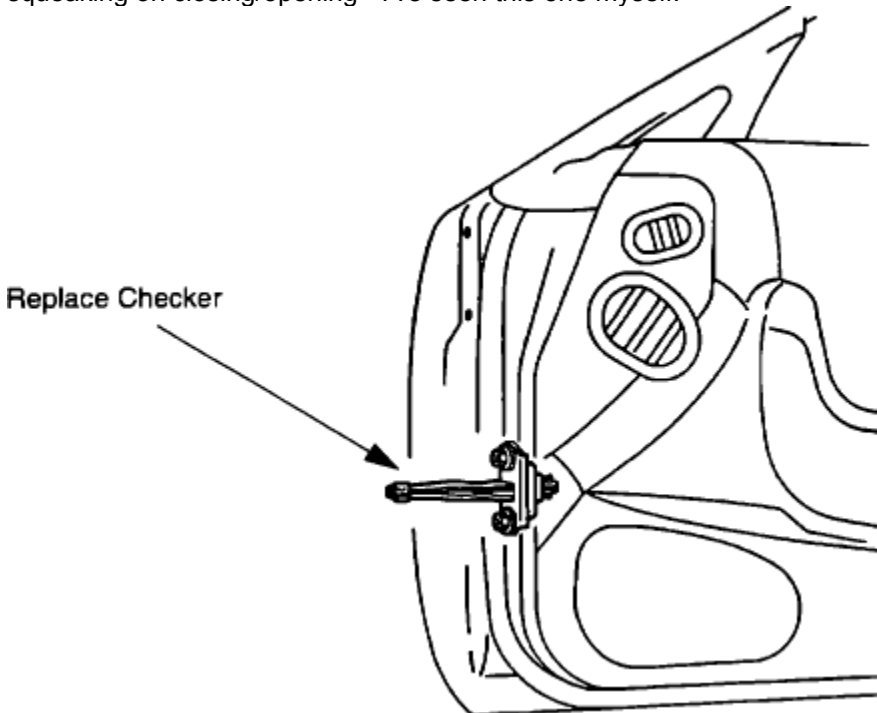
**S01094 FEB 94 Door - Squeaking Noise When Opening or Closing**

This is an interesting one. There's a revised door checker that fixes a problem with the door squeaking on closing/opening - I've seen this one myself.

VINS affected are: JM1FD33"P0200001 through JM1FD33\*\*P0210664  
New part number for the door checker: FD01 58 270B

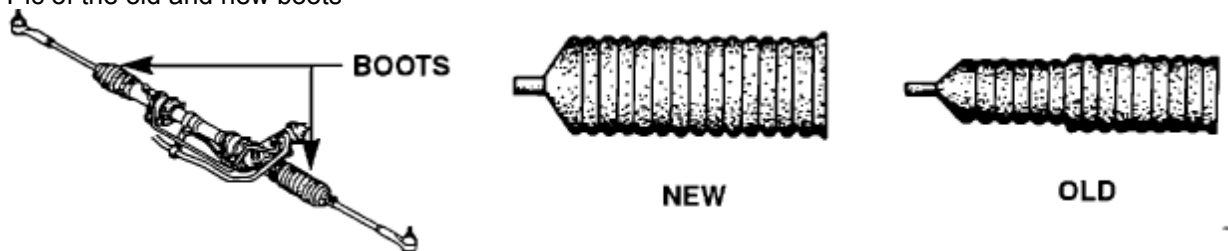
Pic of the old and new boots -

If you turn the steering wheel with your car stopped, you may get a funny noise from the front end. This is due to the design of the boots on the steering rack over the tie rods. The part was updated to fix the problem.

New part numbers are FD01 32 125A and FD02 32 125A for the boots.

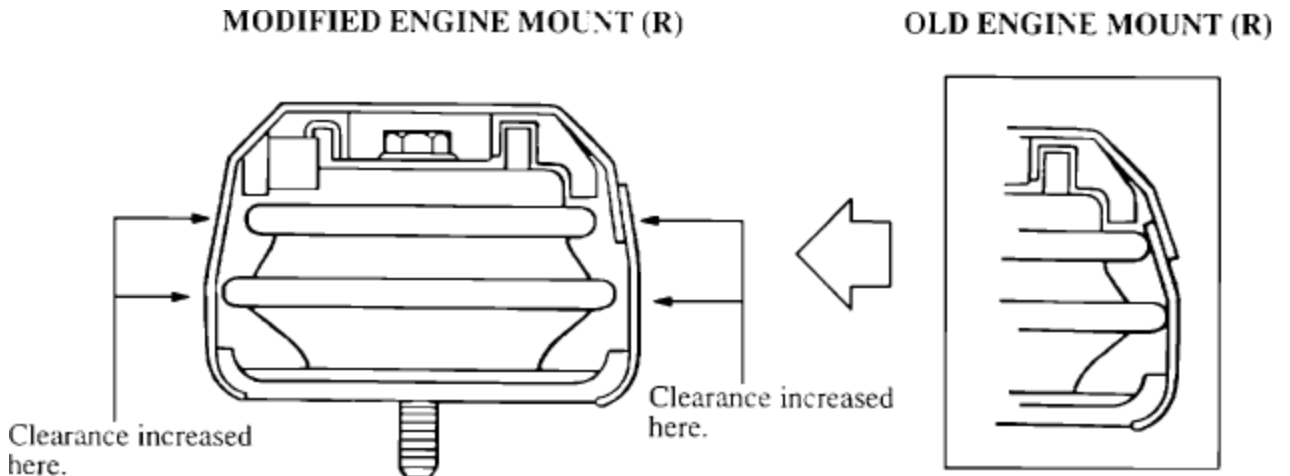
**B00293 FEB 93 Engine - Unusual Noise from the Right Mount**

The right (passenger side) motor mount has been revised. The old part rubbed against the metal case around the mount and made noise. Comparison of the old and new parts -

The old mounts are likely not available any more - any ones you buy now will be the revised part.

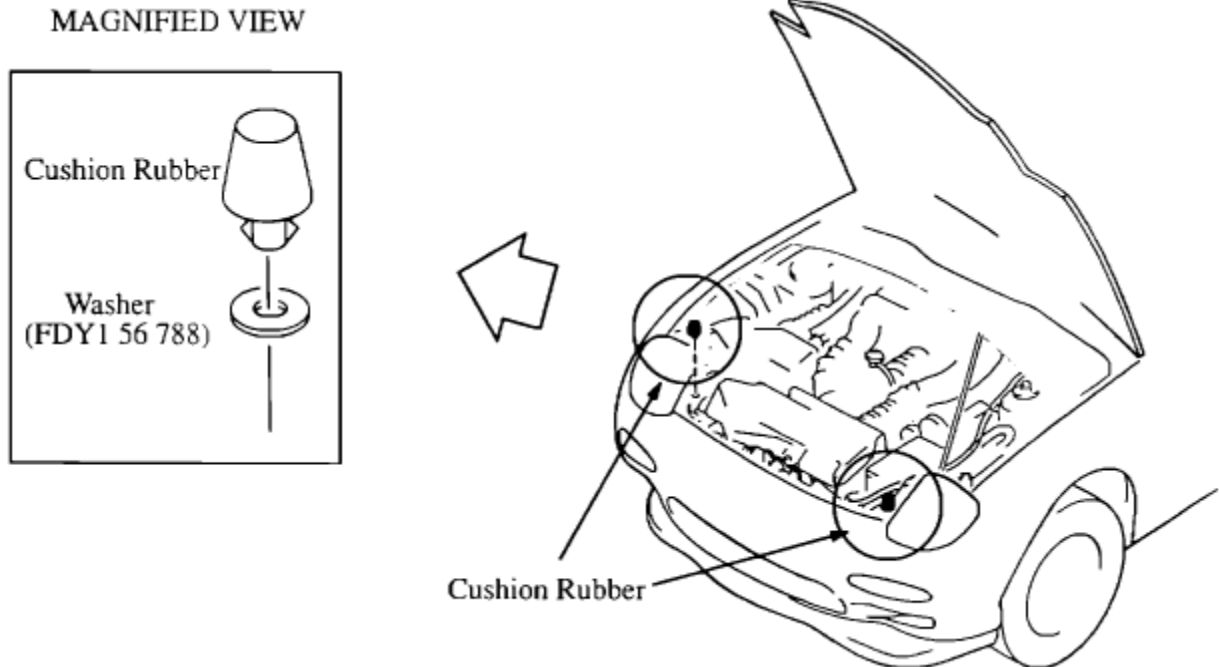
Pic/part number:

You may have a squeak from the hood while driving. Supposedly affects VINs P08750 and lower. All you need is these 2 washers from Mazda to put under the rubber hood bumpers and you're good to go.

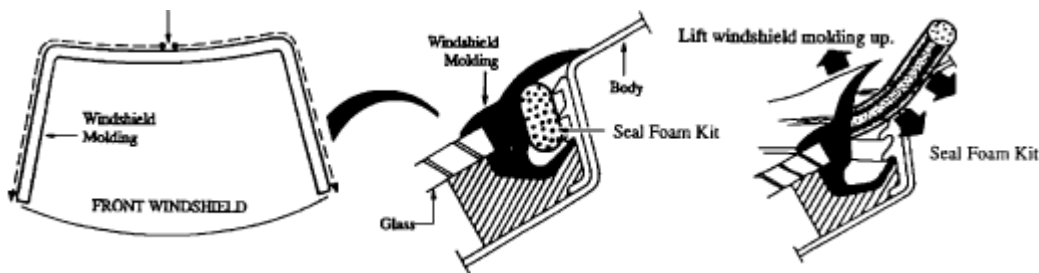
**S04992 OCT 92 Windshield Molding - Whistling Noise**

This is just the addition of some extra sealing foam to the weatherstripping around the windshield if there's a whistling noise at high speed. Here's the pic/how to install the extra sealing foam -

Part number for the foam is B001 77 739.

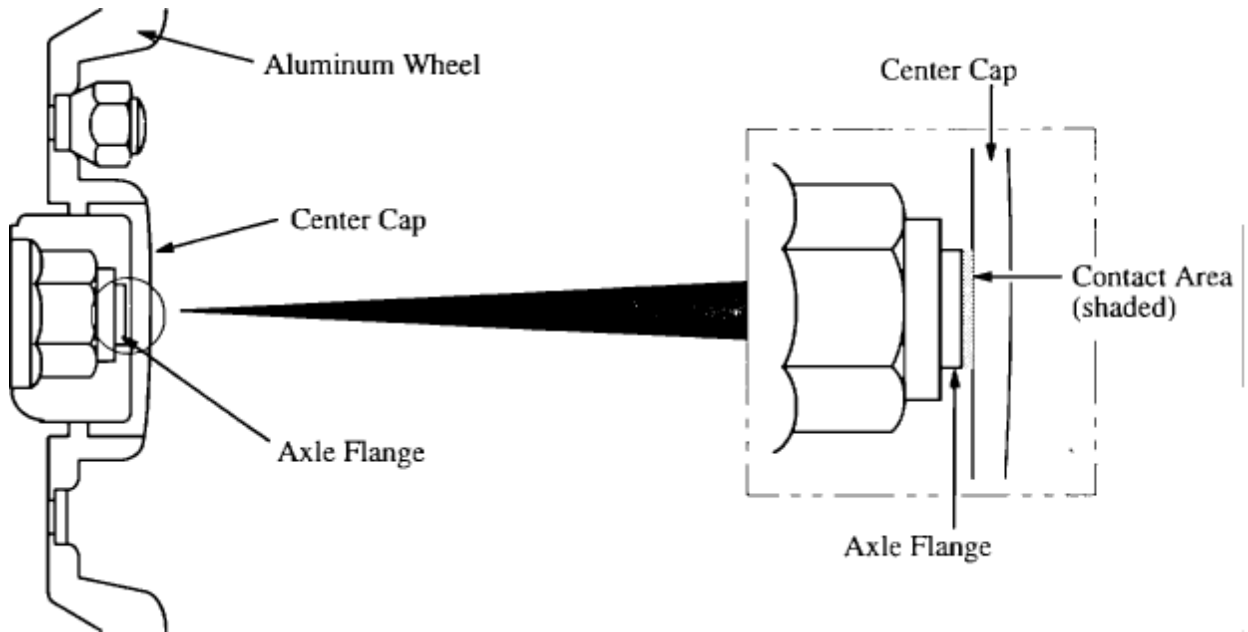
Pic of the problem/interference point:

The wheel cap can interfere with the hub nut and stick out slightly. There's a new part number for an updated cap - FD01 37 191B - or you could probably just dremel out some of the material at the back of the wheel center cap to fix the problem.
